The Parish Church of St Andrew, Shifnal, Shropshire

Six Peal Boards (1774 -1845)

Treatment Report – September 2020

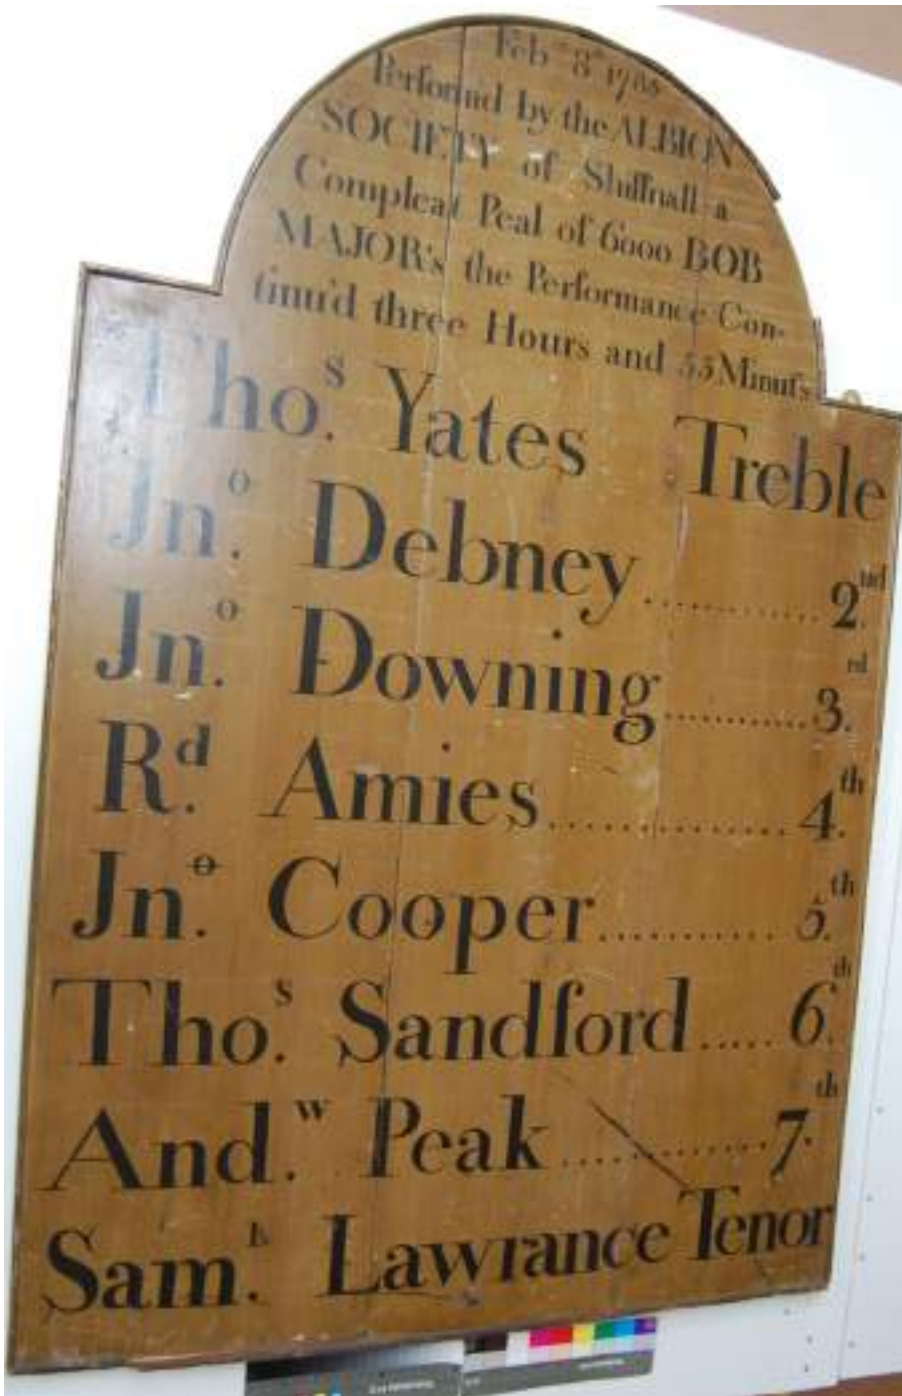
Before treatment in studio (photo taken with painting on table)

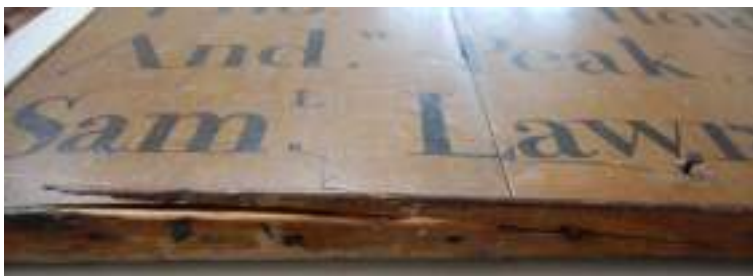
- The painting was transported to my studio in Shropshire
- Having been removed from the wall, the painting was in worse condition than originally observed - the lower edge of the frame was split in two and the painting was no longer structurally stable. With the panels no longer supported by the lower edge of the frame, the two panels on the left were loose and no longer fixed together. This was made worse by damage caused by wood worm to the panels. The area of wood along the joints was very damaged by woodworm, causing losses in the timber on the backs of the panels and a complete failure of the join between the panels on the left. The panels were joined with large iron nails but the woodworm damage along the joints meant that the nails could no longer hold the panels together.

Lower edge before treatment showing split in frame

- The lower edge of the frame that was split in two, and the top right edge of the curved part of the frame which was also damaged with a large loss, were in fact not original but

replacement pieces of wood and were slightly different dimensions to the original frame profile. Both of these damaged and non-original parts of the frame were removed. This made it easy to justify replacing the lower part of the frame rather than mending it, a preferred choice as it would make the panel more structurally stable.

- The panels on the left were re-joined with three wooden dowels.
- The lower edge and top right part of the frame were replaced with white oak cut, planed and shaped to size. The lower edge was curved to match the curvature of the panel. The top right piece for the curved edge of the frame was steamed to shape it to the correct curvature. The new pieces were screwed onto the edges of the panel. Panel pins were used to re-attach the lifting part of the frame on the left shoulder.

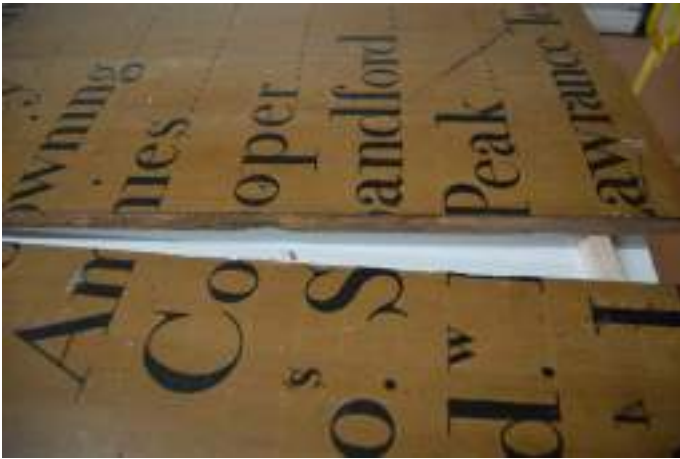
Open join in left panels

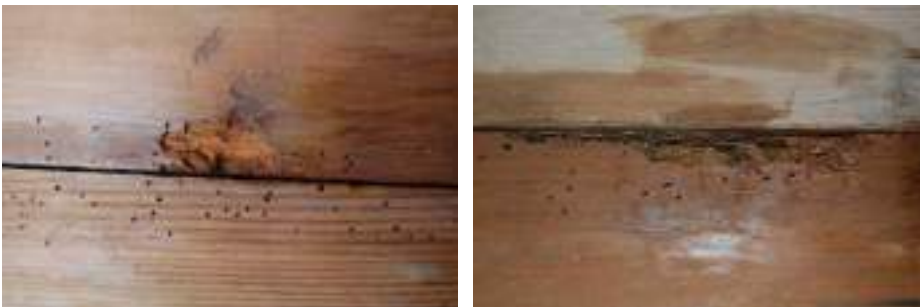
Wood worm damage on back of panel

- The woodworm damage on the back was examined and appears to be old, with no recent looking flight holes. The areas of damage were treated nevertheless with permethrin to help prevent further infestations. The areas damaged by the flight holes were consolidated with Paraloid B72 (10% in Shellsol A100). The process was repeated several times in order to consolidate the timber sufficiently to make it more structurally stable. The losses in the timber were filled first with a filler made of Resin W, sawdust and micro-balloons. The tops of the losses were further filled with Osmo wood filler.

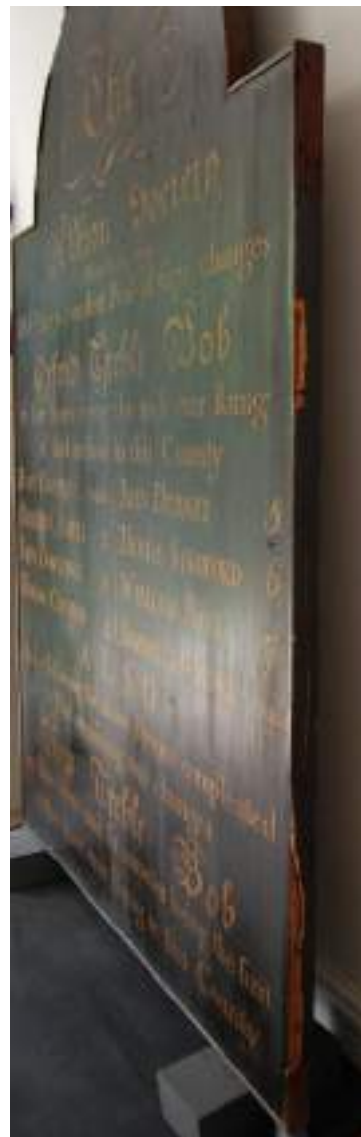
Damage to right edge of frame

- Areas of unstable paint were consolidated with Lascaux Medium for Consolidation.
- The damaged part of the frame on the right side was removed and replaced with a strip of white oak cut and planed to shape. The damaged part of the frame at the top left curved edge was also removed and replaced with a strip of white oak cut, planed and shaped to size and to match the curvature of the panel. These replacement strips of wood were attached with screws.

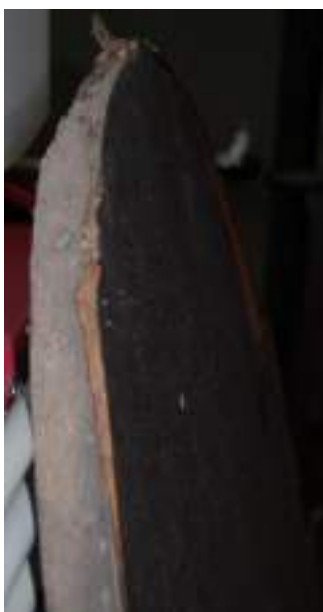
Damage to top of frame

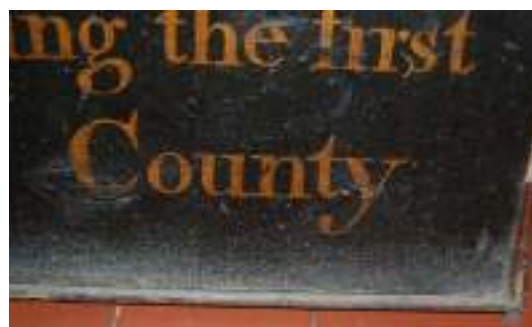
Dust along lower edge and loss in lettering

- The new strips of wood were painted with Golden® Acrylic paint and Gold Imitation gouache paint.
- Losses in the paint and lettering were retouched with dry pigments bound in Paraloid B72 and Gold Imitation gouache paint.

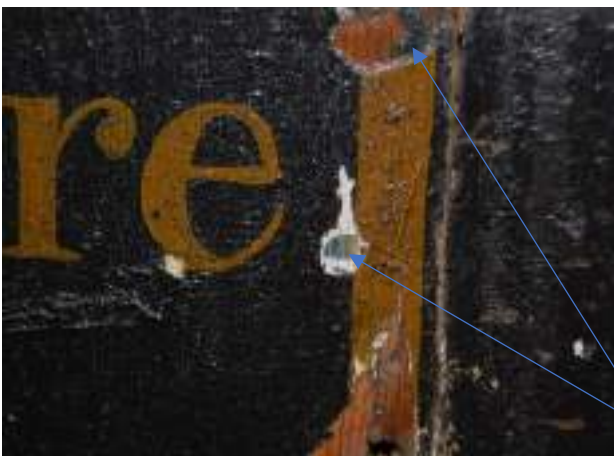
Detail showing older scheme visible in paint losses

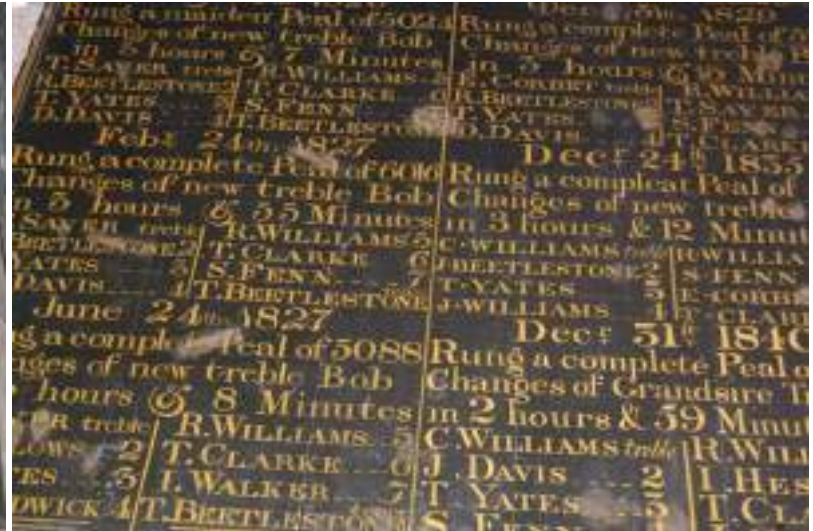
Detail showing areas of drying cracks

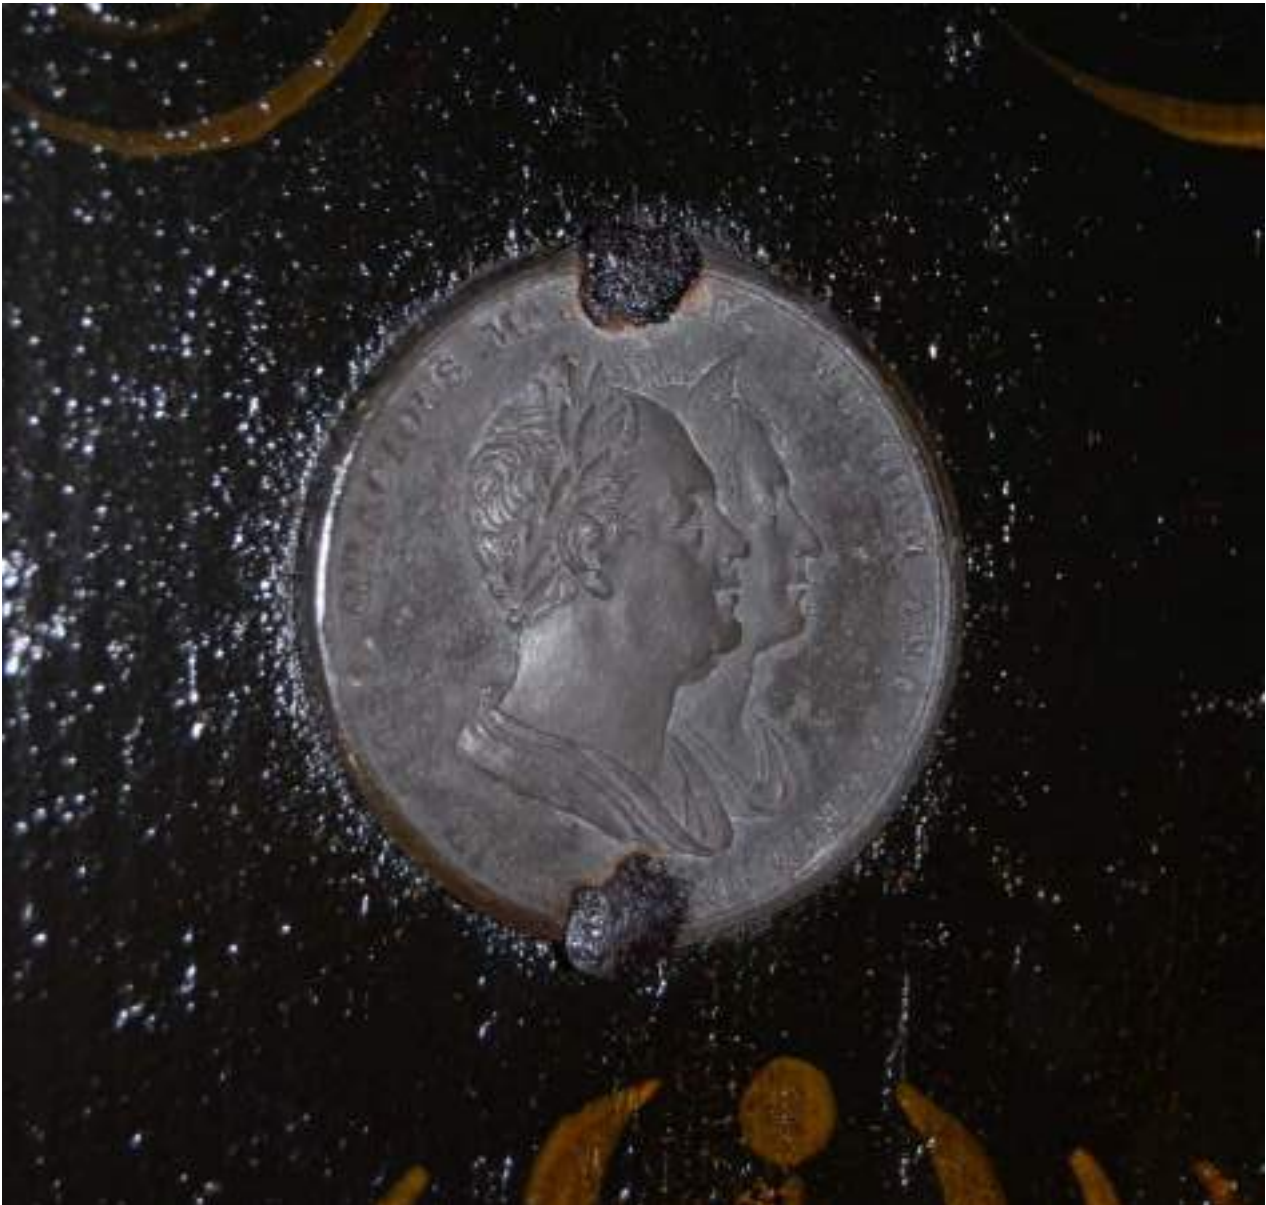
- The painting was conserved in the church in the North transept.
- Closer examination of the metal medallion shows that it may refer to the coronation of William IV in 1831 as it reads: 'THEIR MOST GRACIOUS MAJESTIES WILLIAM AND ADELAIDE'. The nails fixing it to the board are very corroded. They were coated with Paraloid B72. It is unclear what the metal is but it is quite soft and light grey in colour.

Detail of medallion that reads: THEIR MOST GRACIOUS MAJESTIES WILLIAM AND ADELAIDE

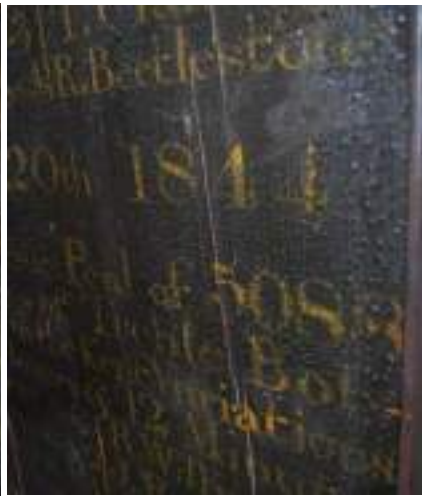
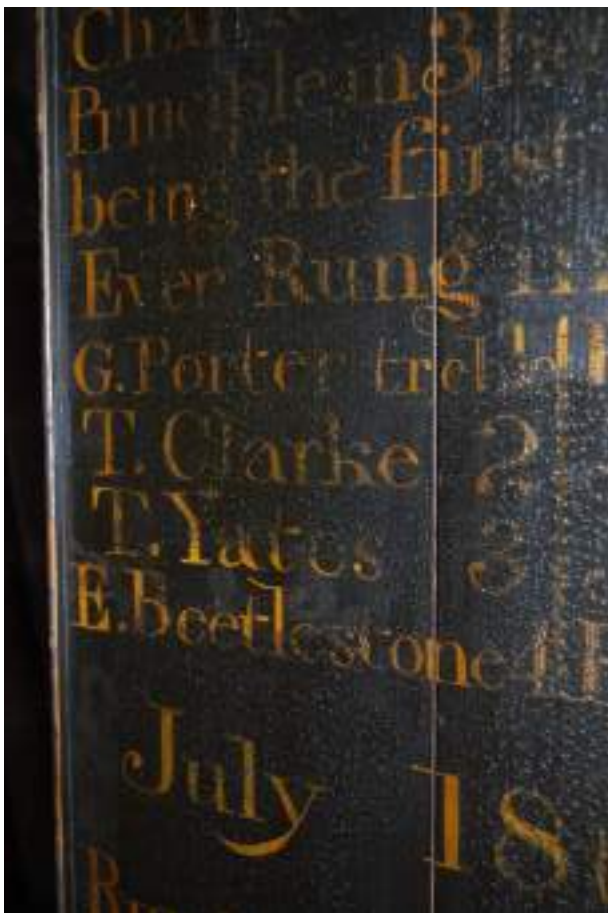
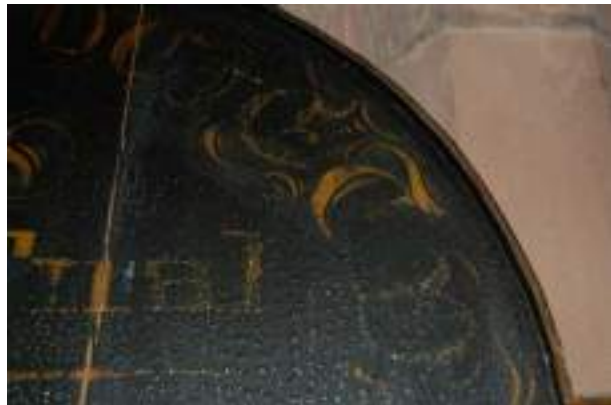
- The corroded tacks on the back horizontal battens were treated with Kurust to prevent further corrosion.
- The front was dusted and surface cleaned with a 3% solution of Tri-ammonium citrate in de-ionised water, cleared with de-ionised water. Closer examination of the paint layer showed a great unevenness in the lettering. Most of the lettering was very faded and distorted, and difficult to read as a result of the severe drying cracks. But a few localised areas of paint were intact and it appears that this has been caused by the painter randomly and locally applying something to the surface that has protected areas of paint, possibly preventing the underlying layers from distorting as they dried.

Details showing unevenness in condition of lettering

- Losses on the frame and in the paint and lettering were retouched with Golden® Acrylic and dry pigments bound in Paraloid B72. A lot of the lettering had to be retouched in order to make it legible. It was not all retouched to the level of the most intact lettering as this would have meant repainting most of the letters, but was retouched enough to give a more even and coherent appearance.

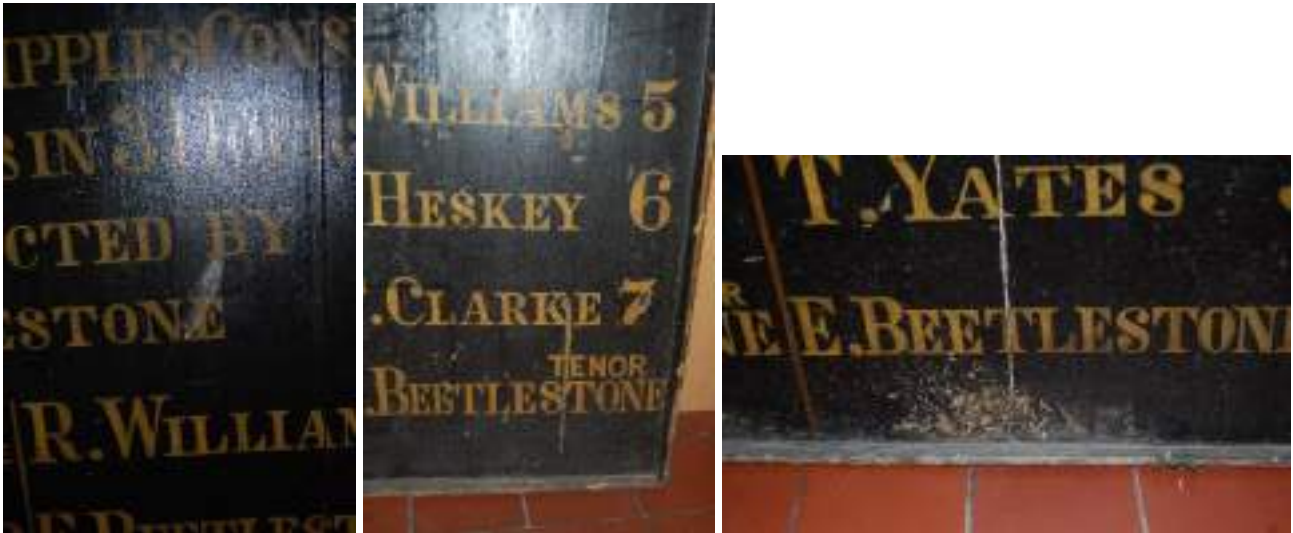
Details showing losses in paint

- Losses in the paint and lettering were retouched with Golden® Acrylic and dry pigments bound in Paraloid B72.
- The painting was brush varnished with a thin layer of Laropal A81. Further glazing of the losses and lettering was carried out with dry pigments bound in Laropal A81.

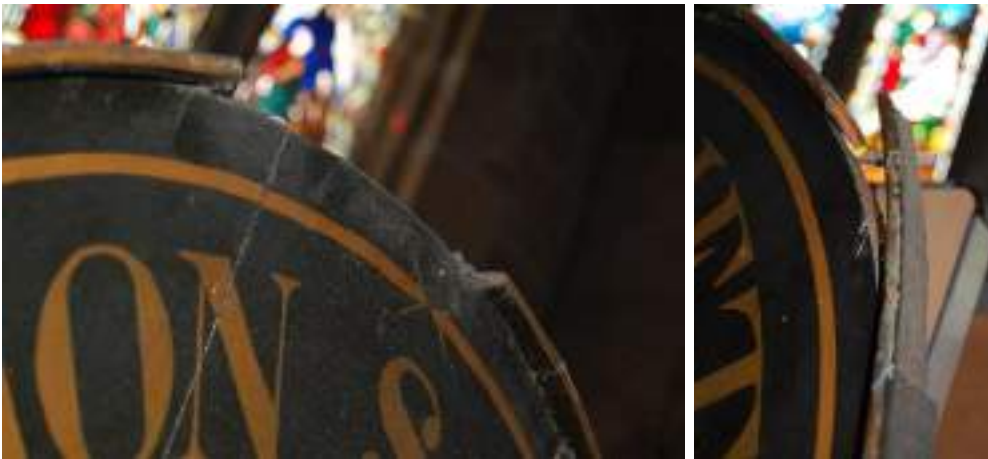
Details showing damage to frame

- The loss in the top part of the frame was replaced with the strip of white oak cut, planed and shaped to size.
- Losses and replacement timber in the frame were retouched with Golden® Acrylic and dry pigments bound in Paraloid B72.

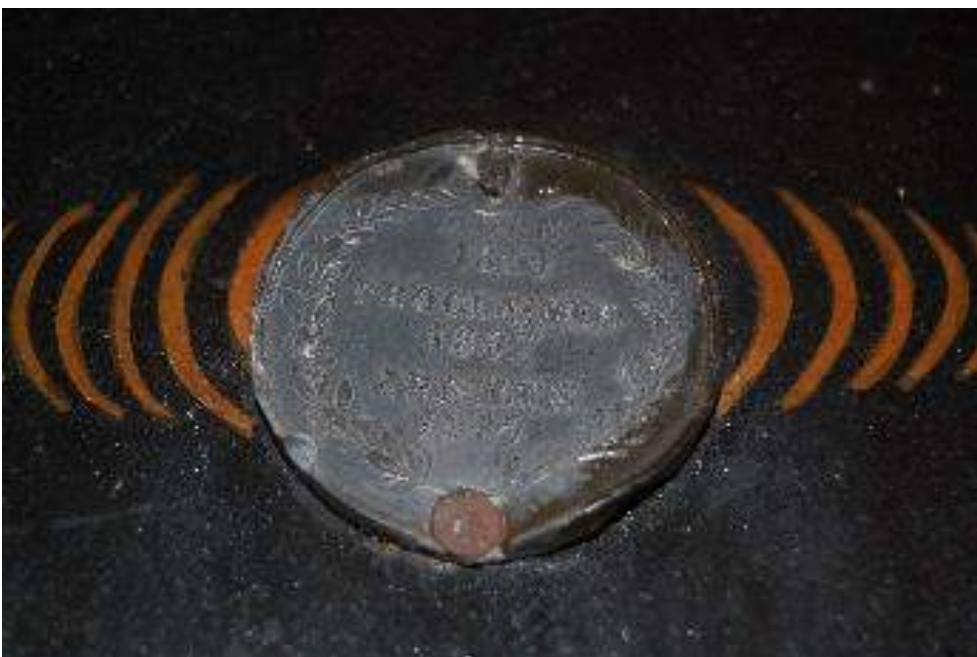
- The painting was transported to my studio in Shropshire.
- Closer examination of the medallion show that it reads: 'BORN 1819 / PROCLAIMED 1837 / JUBILEE 1887'. It is unclear what the metal is but it is quite soft and grey in colour. The corroded tacks on the medallion were coated with Paraloid B72.

Detail of medallion
